Navajo Abandoned Uranium Mine Site Screen Report

Nanabah Vandever AUM Site

Navajo AUM Eastern Region

May 2009

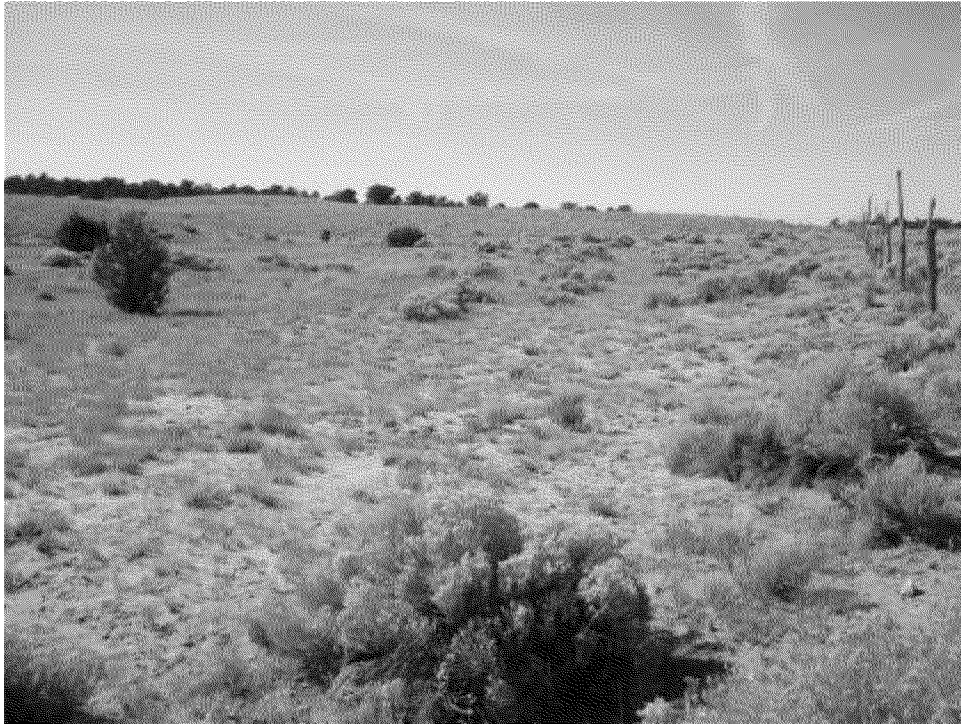
Reclamation status of the mine site is currently unknown. The mine appears to have been reclaimed by dirt covering waste piles. The mine is fenced and posted with signs warning of underground radiological hazards. The signs were faded and nearly illegible. No adits or other mine features were observed during the site visit.

Photo 3. Nanabah Vandever Mine site, suspect covered waste piles

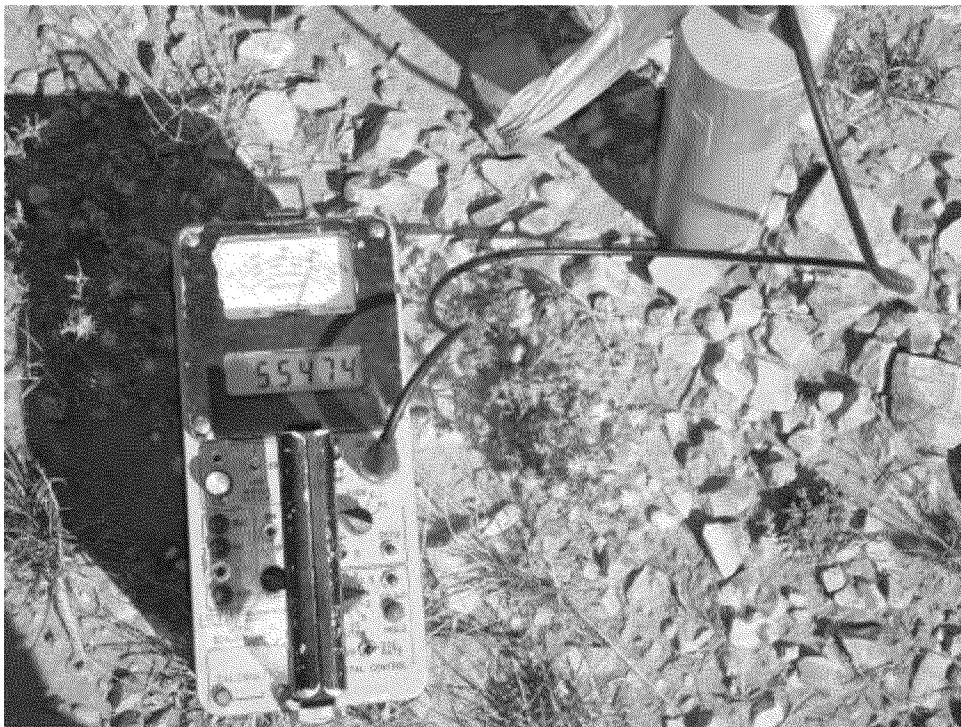
Photo 4. Nanabah Vandever Mine site, waste rock emitting gamma radiation

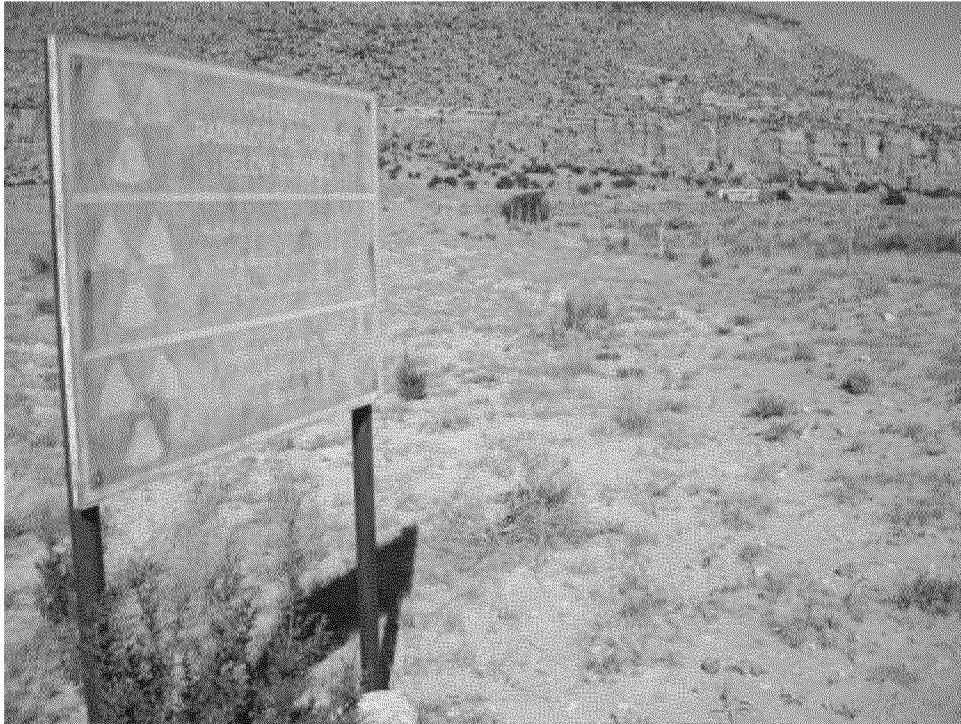
Photo 5. Nanabah Vandever Mine site, faded sign warning of subsurface radiological hazards

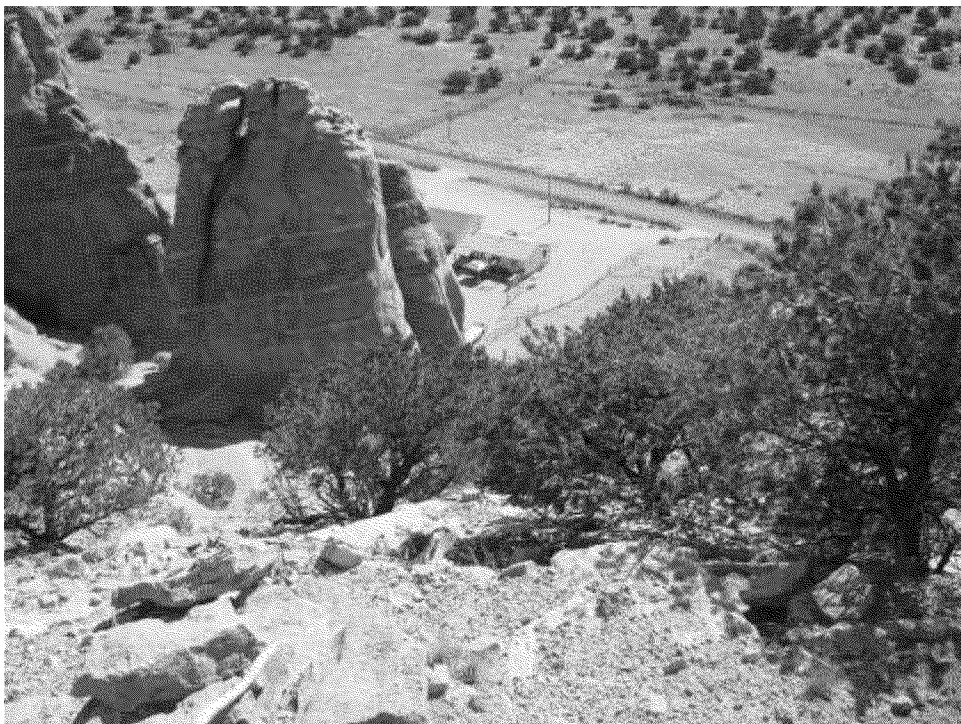
200 feet to 0.25 mile: A Church and an attached residence are located downhill from the mesa approximately 700 feet south of the site

Photo 6. Nanabah Vandever Mine site, view of church from mine

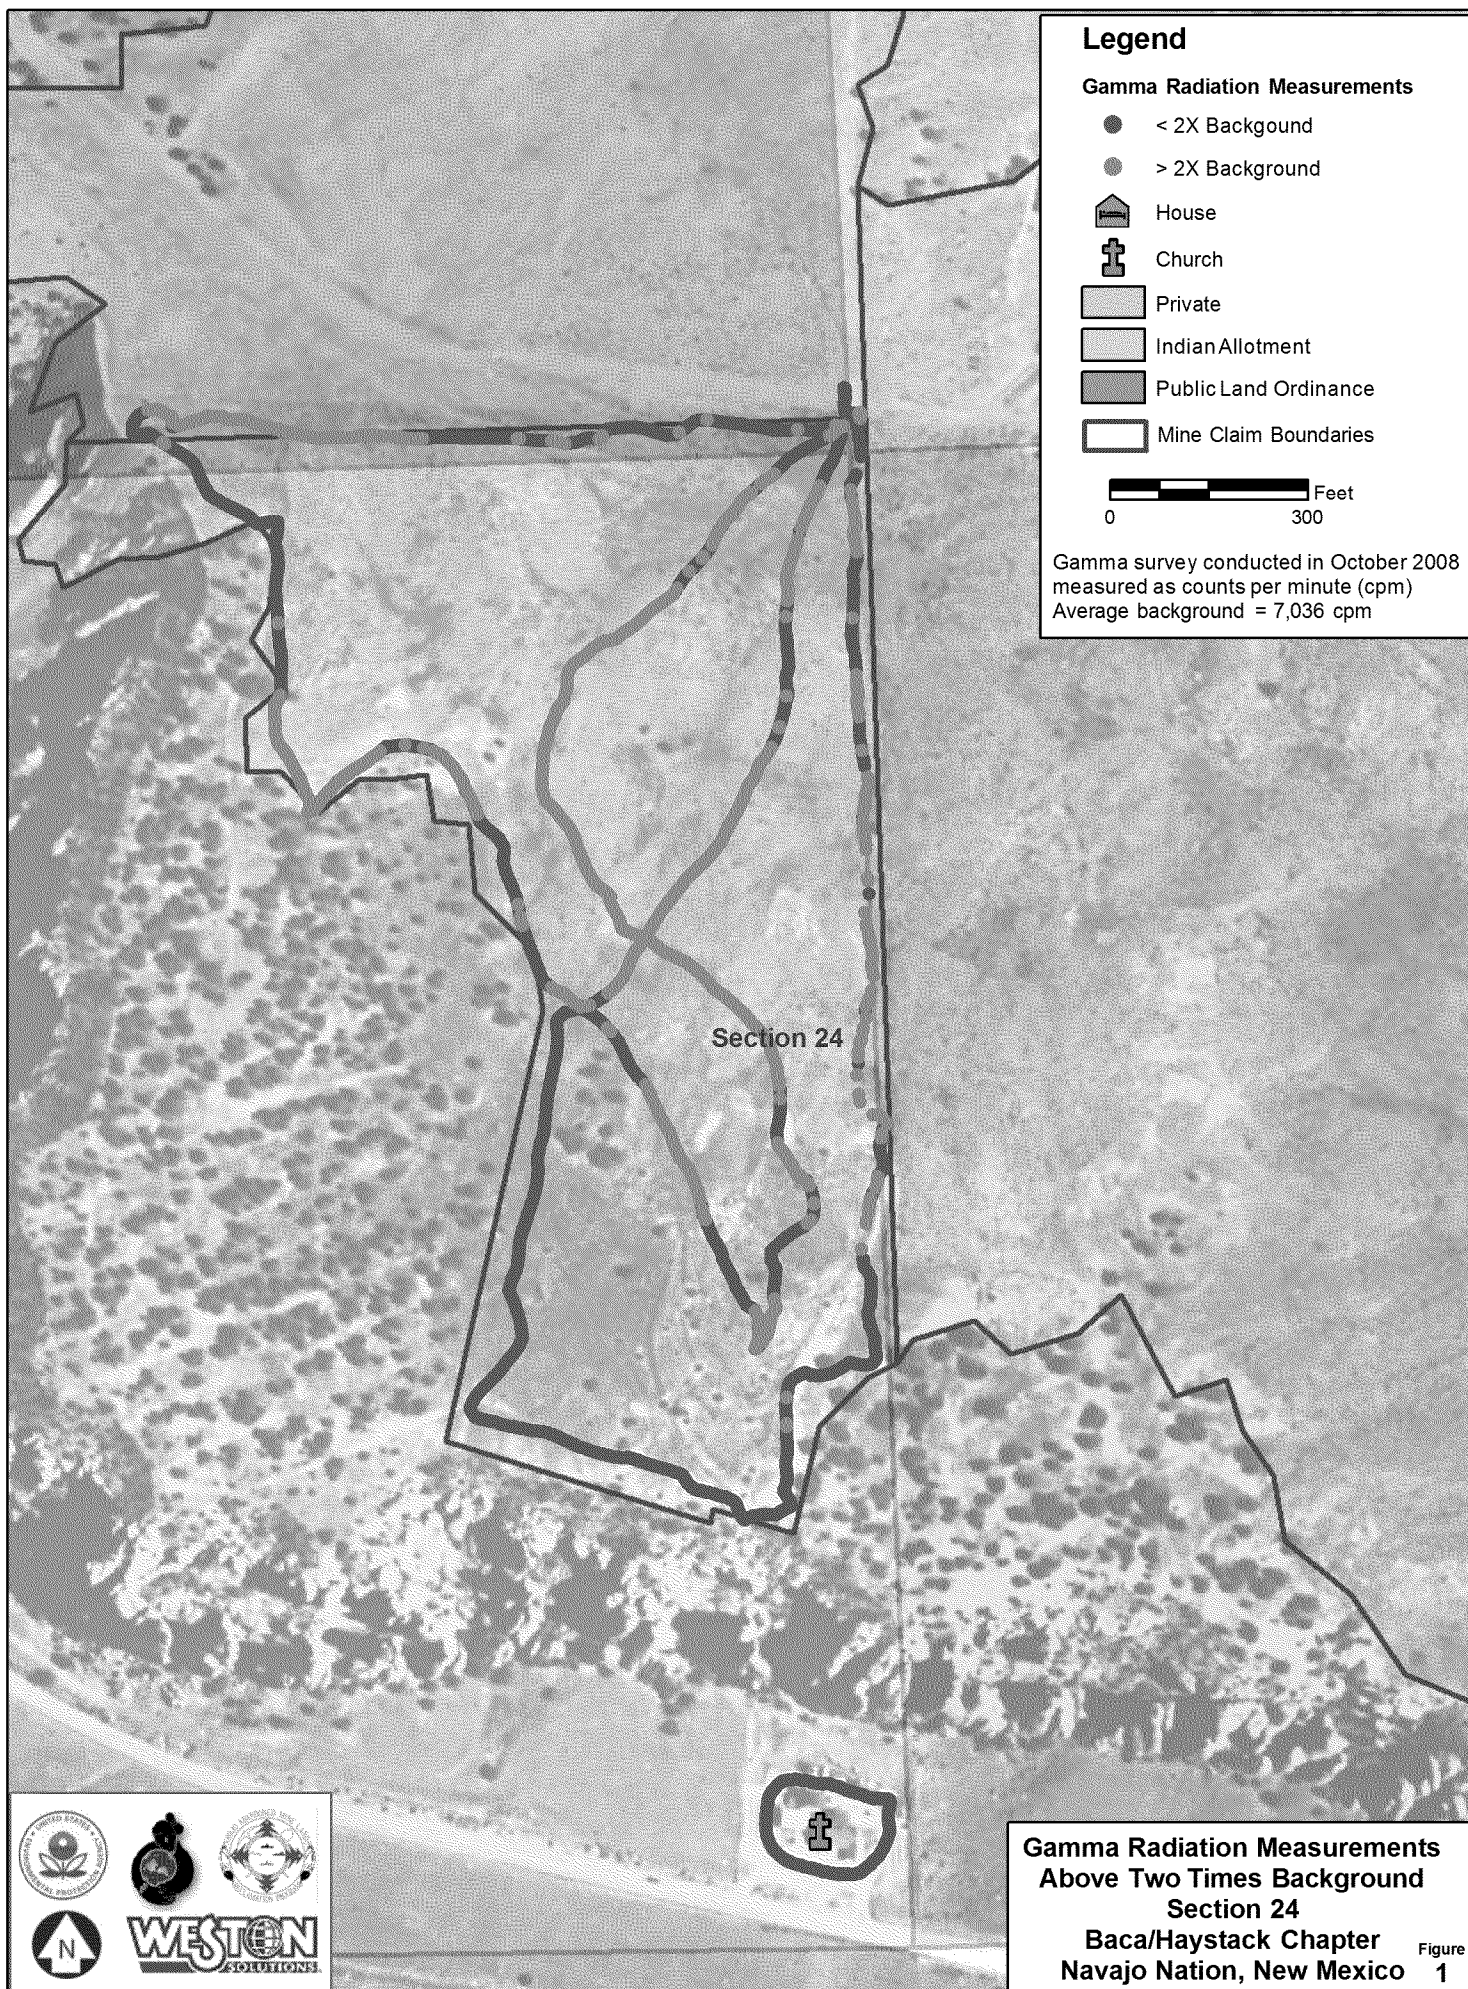
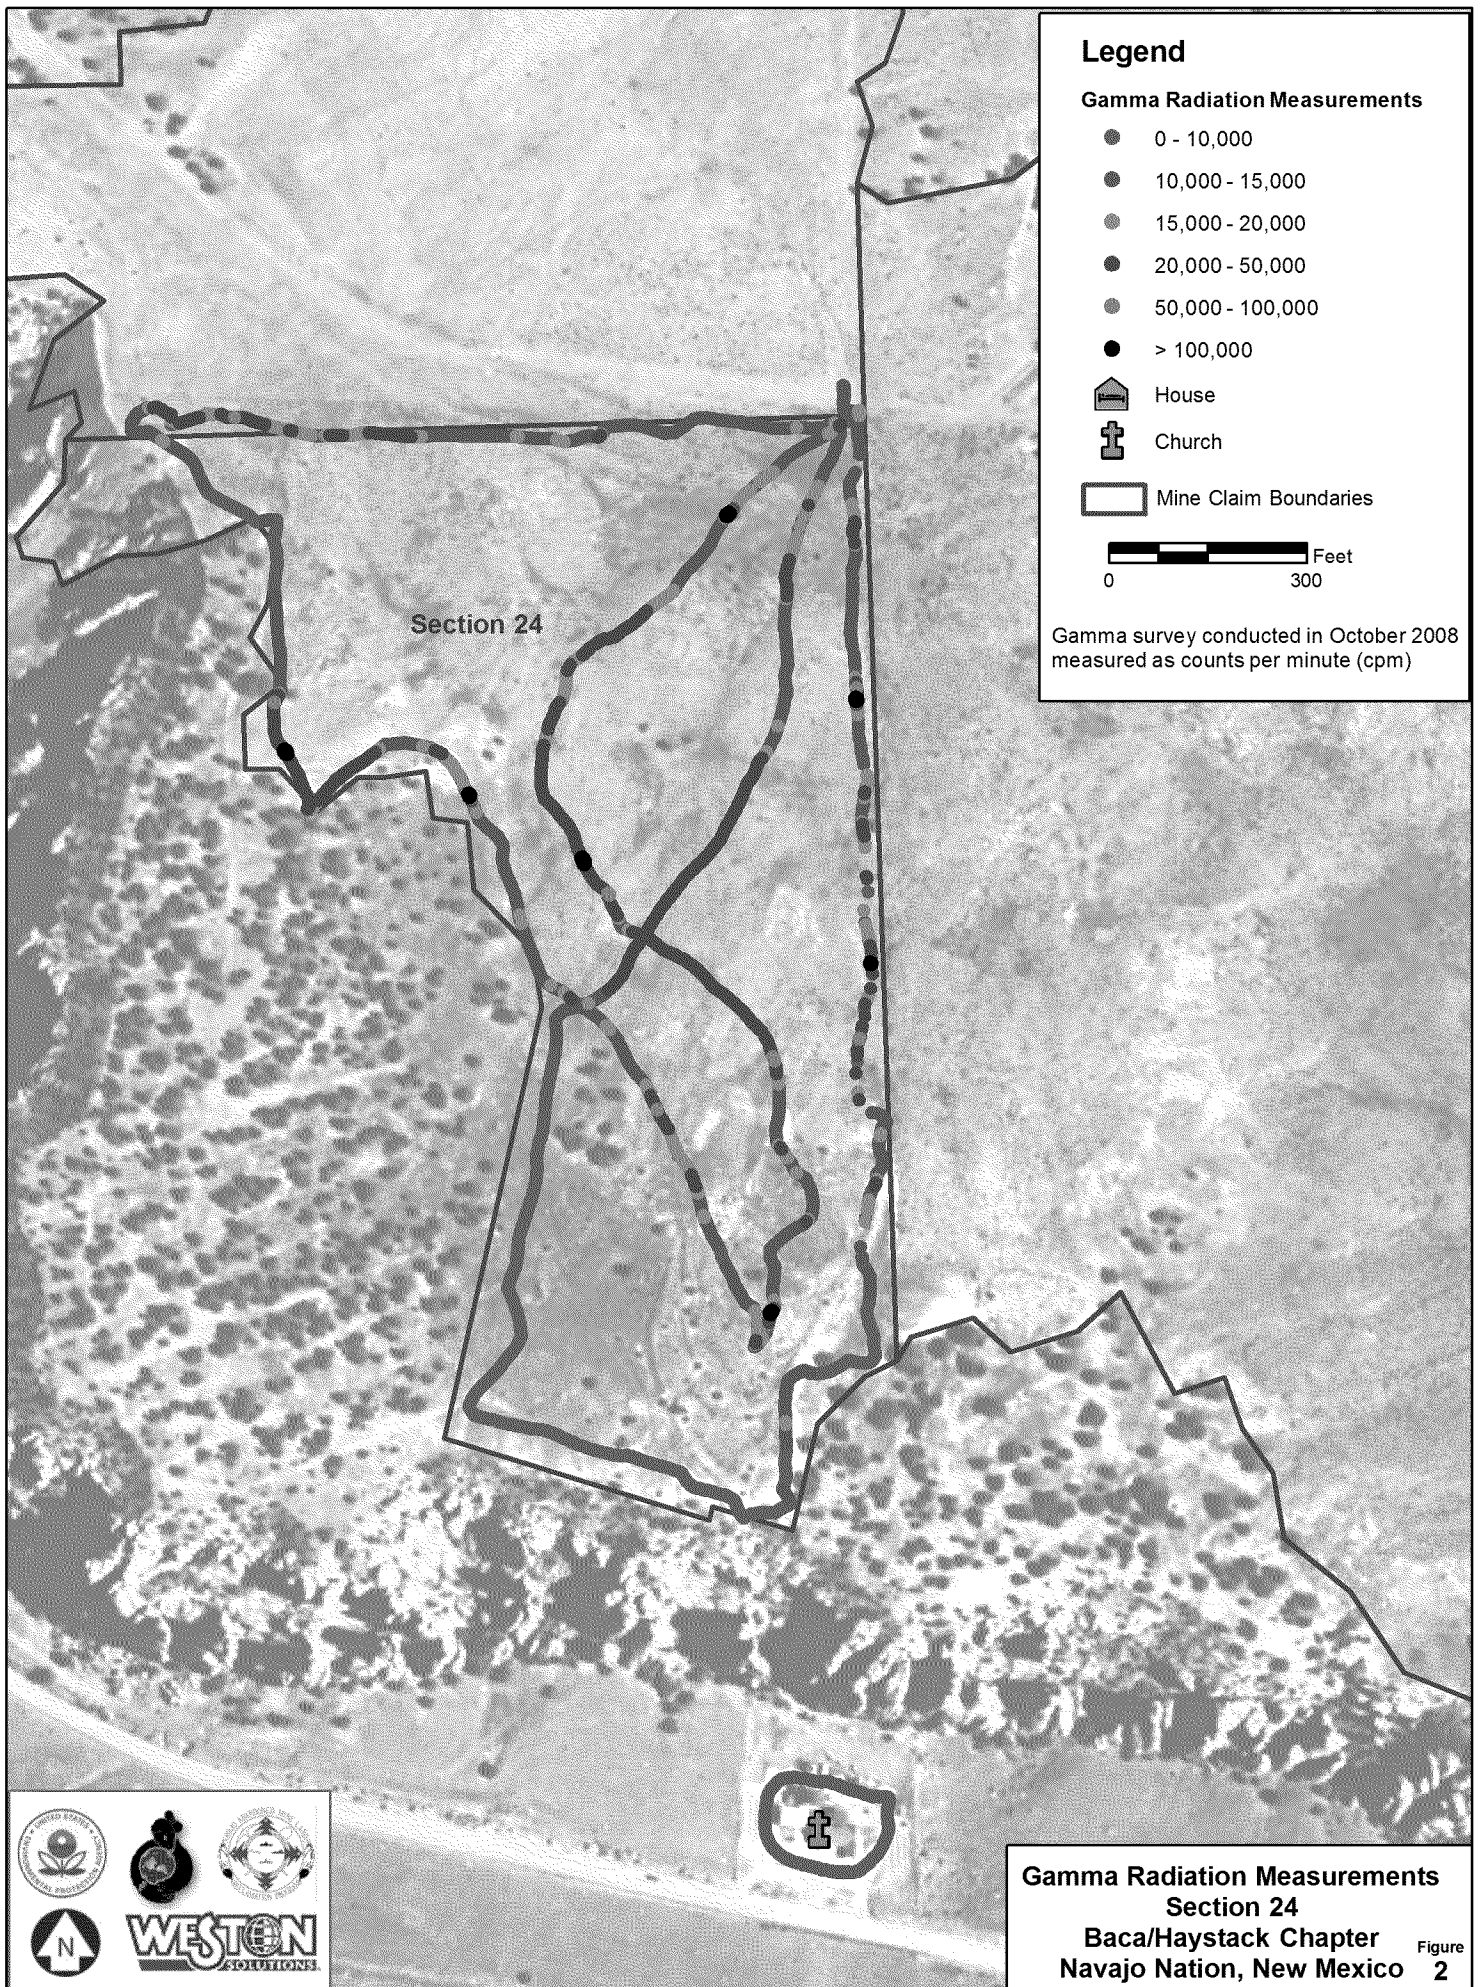
- See Figures 1 and 2

A total of 3,024 gamma radiation measurements were collected from mine sites, ranging from 4,569 cpm to 594,083 cpm. The measurements are represented in Figures 1 and 2.

Presented in Figures 1 and 2
